# Construction of the Alcan Highway 1942

**“ One of the Top 10 Construction  
Achievements of the 20th Century”**

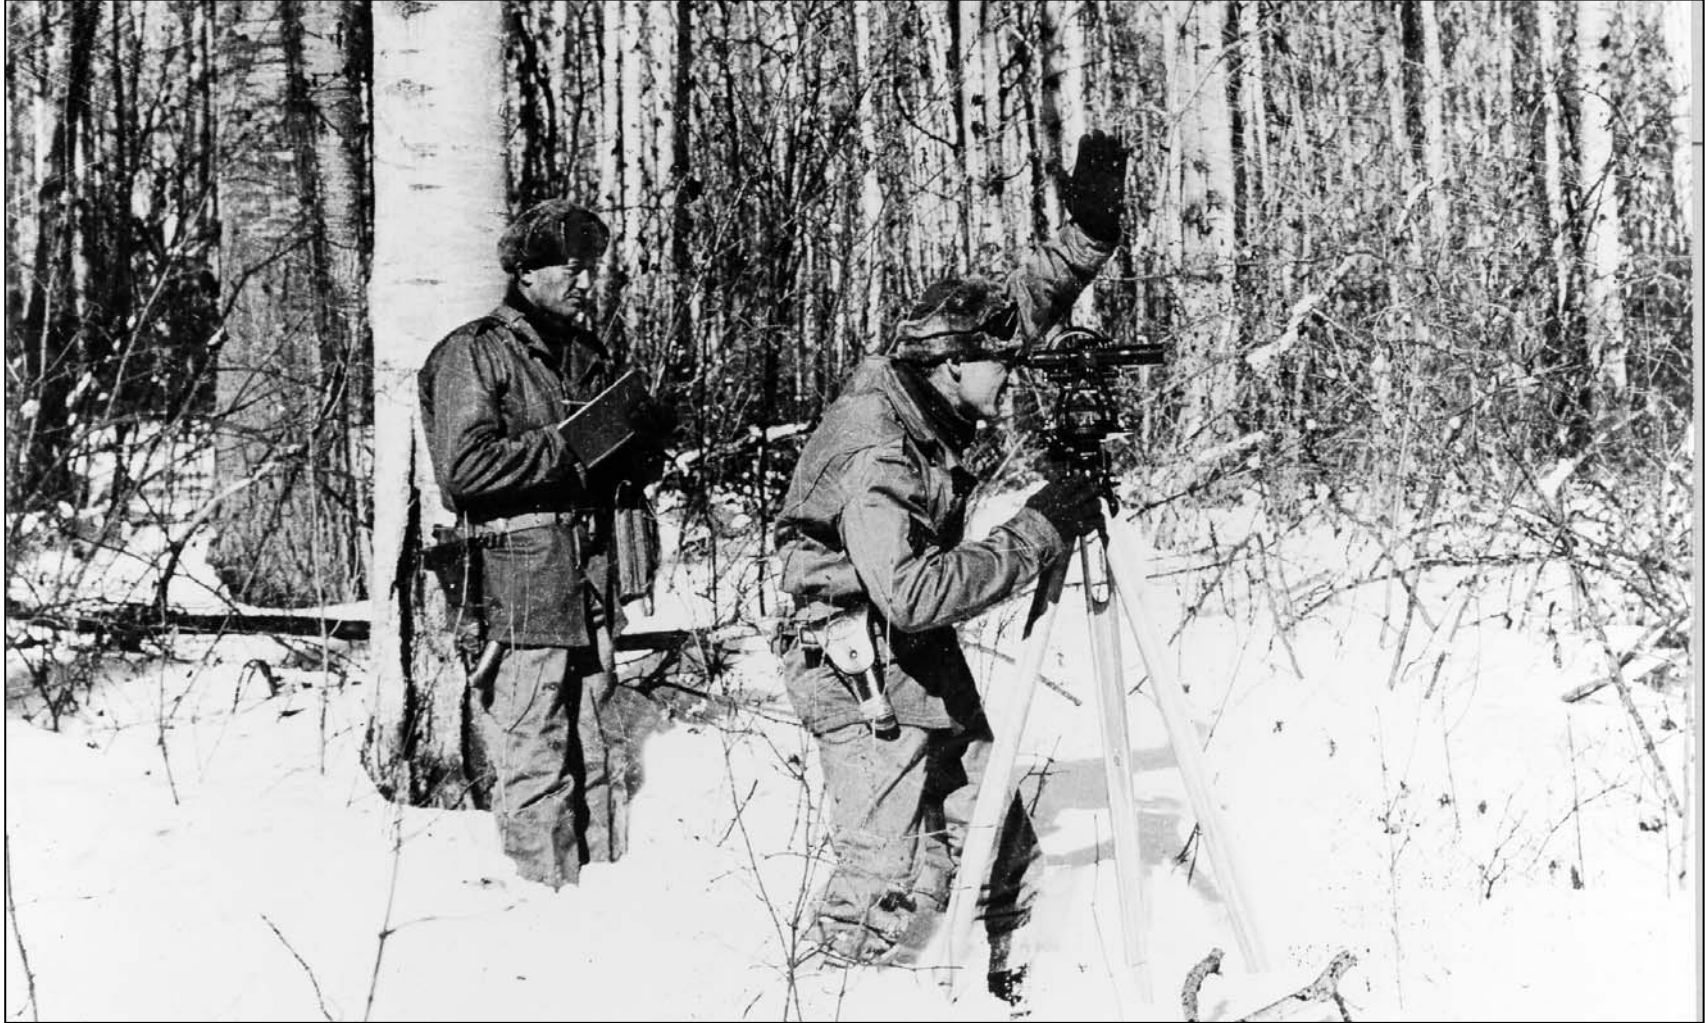
# Survey Party recording and marking center line

- Another survey team would follow behind, running a level survey and tape the centerline. Shortly behind them came the transit team that would record the centerline and elevations of the proposed road.

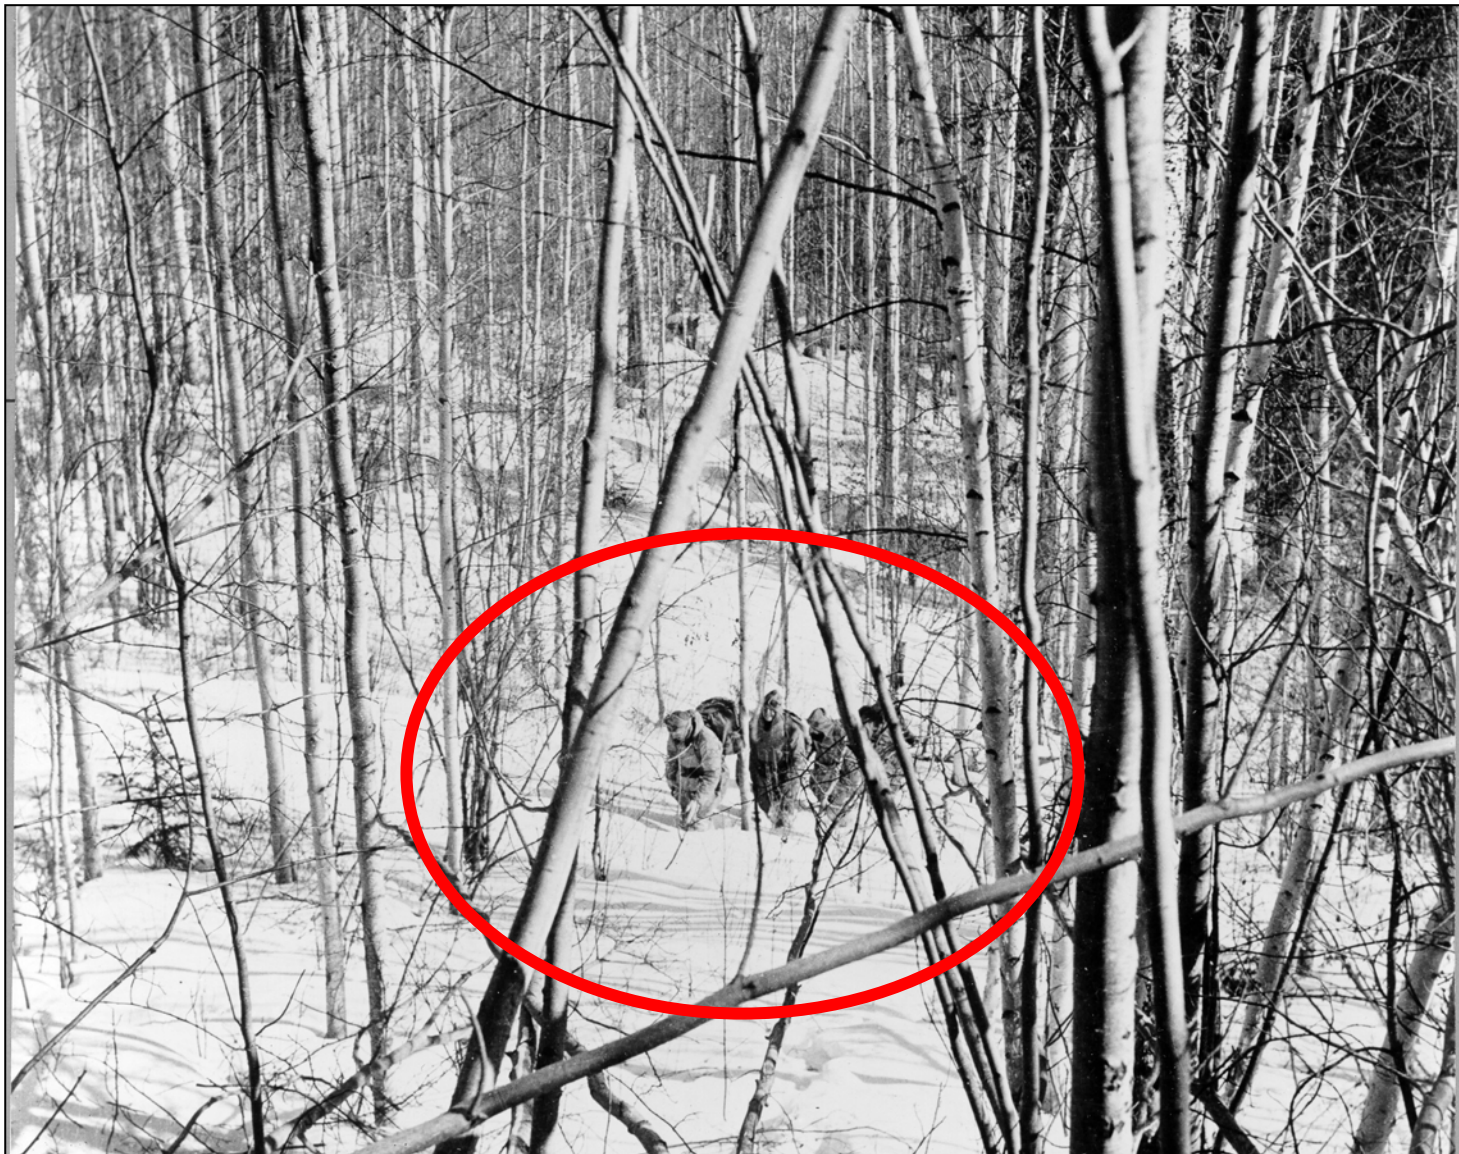
- Route surveying was made difficult by the adverse weather and heavy vegetation, which limited sighting distance

A traverse team and recorders do final calculations to verify that the intended road meets specifications.

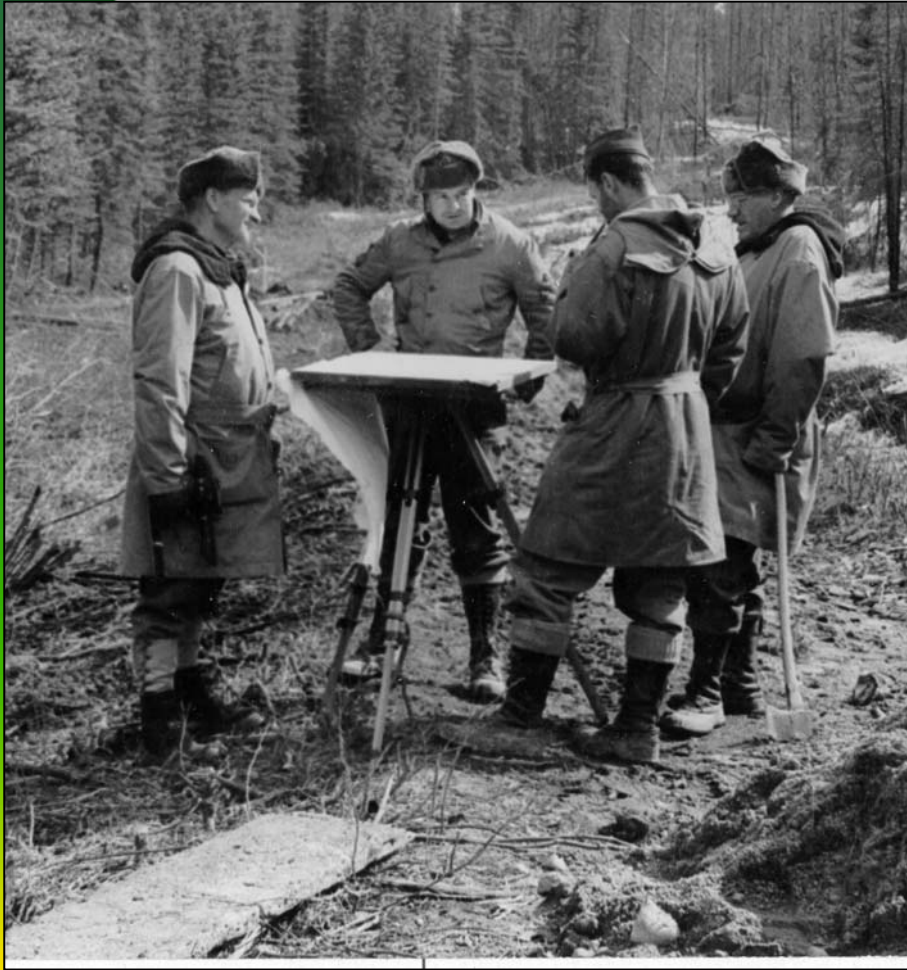
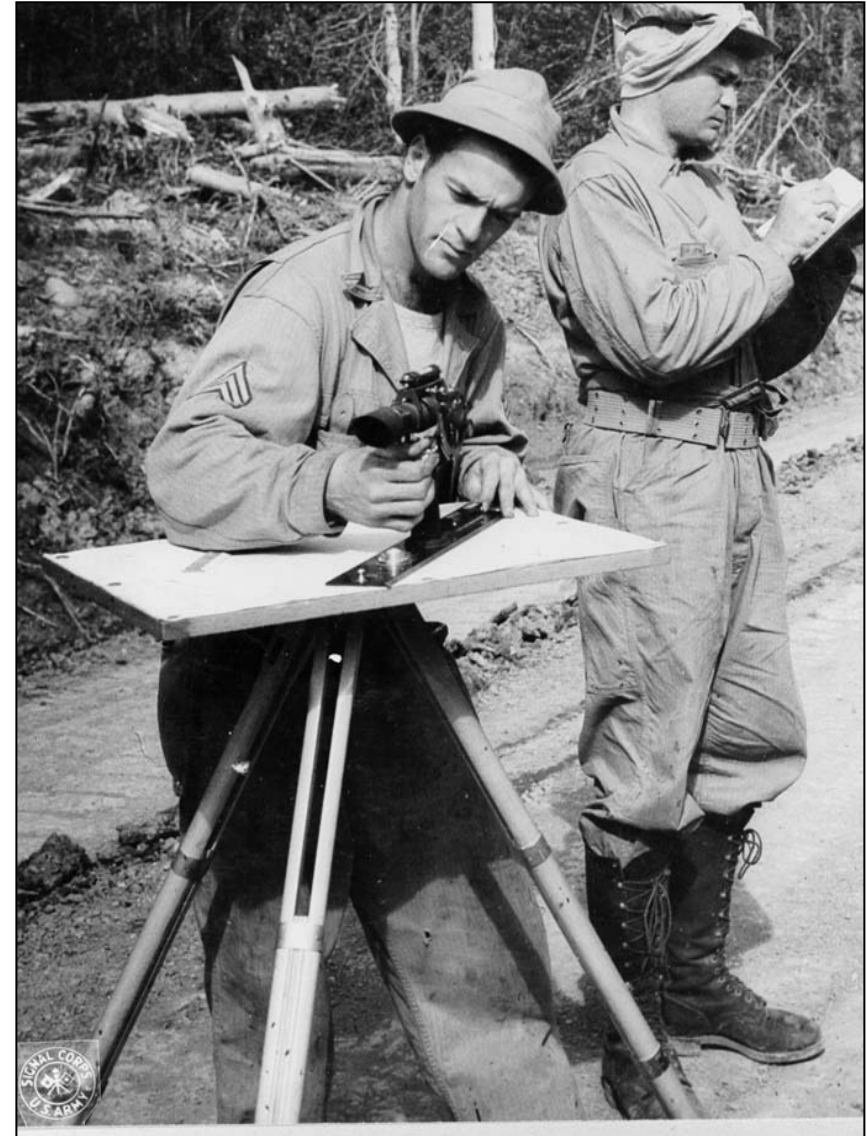
- These shots show two of the plane table survey teams, who fixed vertical elevations along the path

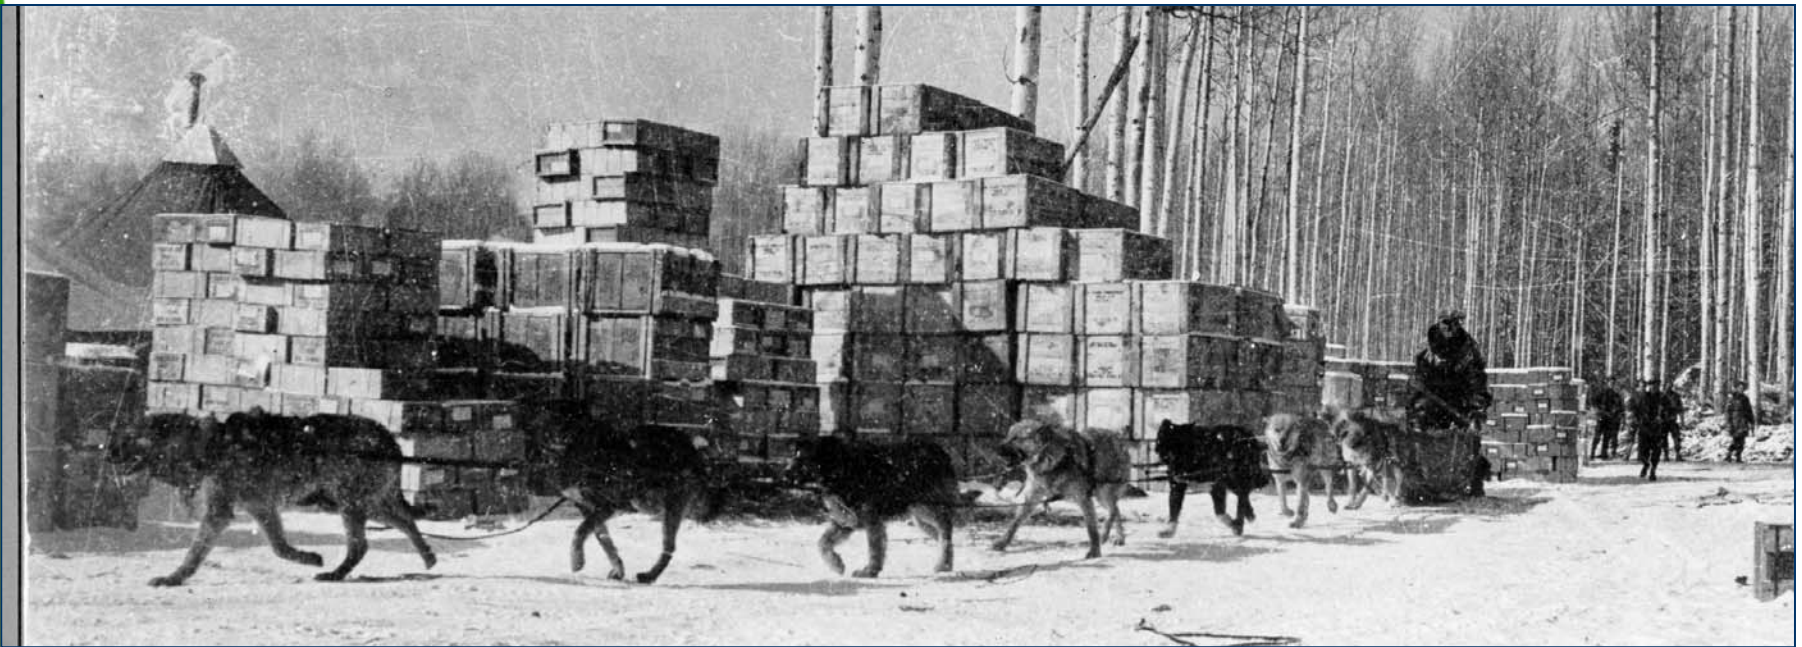
# DOG SLEDS

- **With no defined road established during surveying, supplies were brought to the parties either by dog sled teams or horses. From the start, the supply team would leave with a months supply carried by dog sleds.**

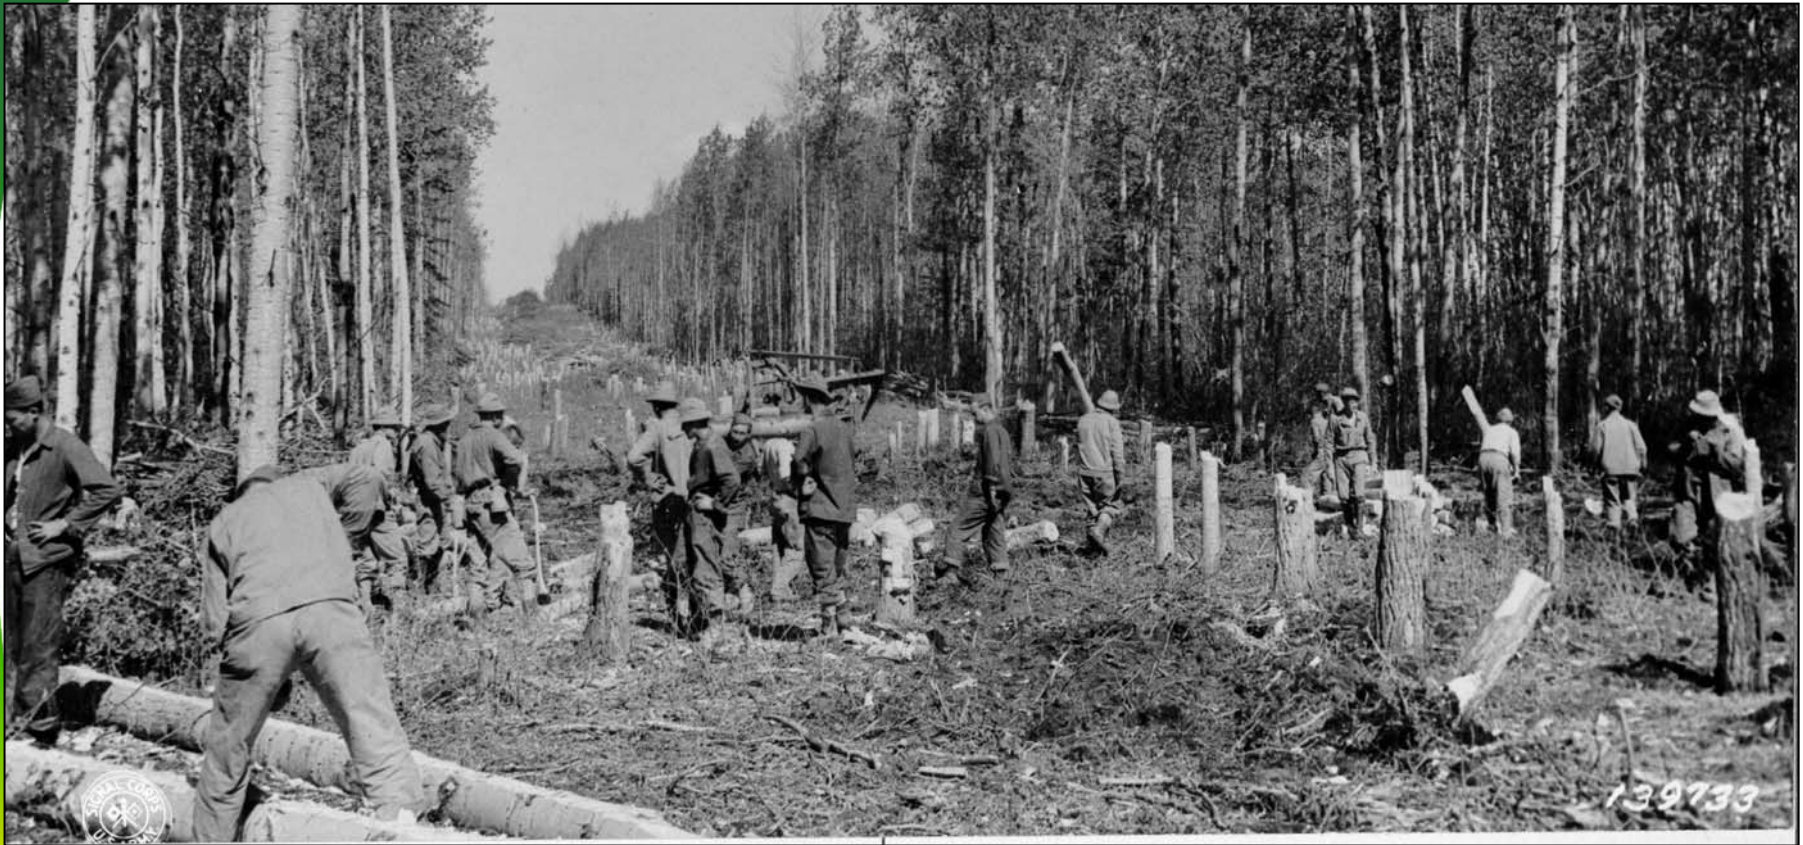
# Leap Frog Grading

**For the first few months of construction, the Engineers had to use muscle and determination to blaze a road.**

- **Within each Regiment, the companies constructed a portion of the road using a leap-frog method. One company would grade their assigned section, another just ahead of them (about 30 miles). When a company worked up to the next company's road, then they would "leap ahead" and start again.**
- **During the spring and summer months, daylight could last up to 20 hours with twilight for the remaining 4 hours. This allowed the construction crews to work 3 shifts of 8 hours each, round the clock.**
- **The units only had a short supply of equipment until the arrival of heavier equipment (CAT D-7's and D-8's). For the most part, they were using hand saws, hand axes and small D-4 bulldozers. Building the road took a lot of brute force and creativity.**

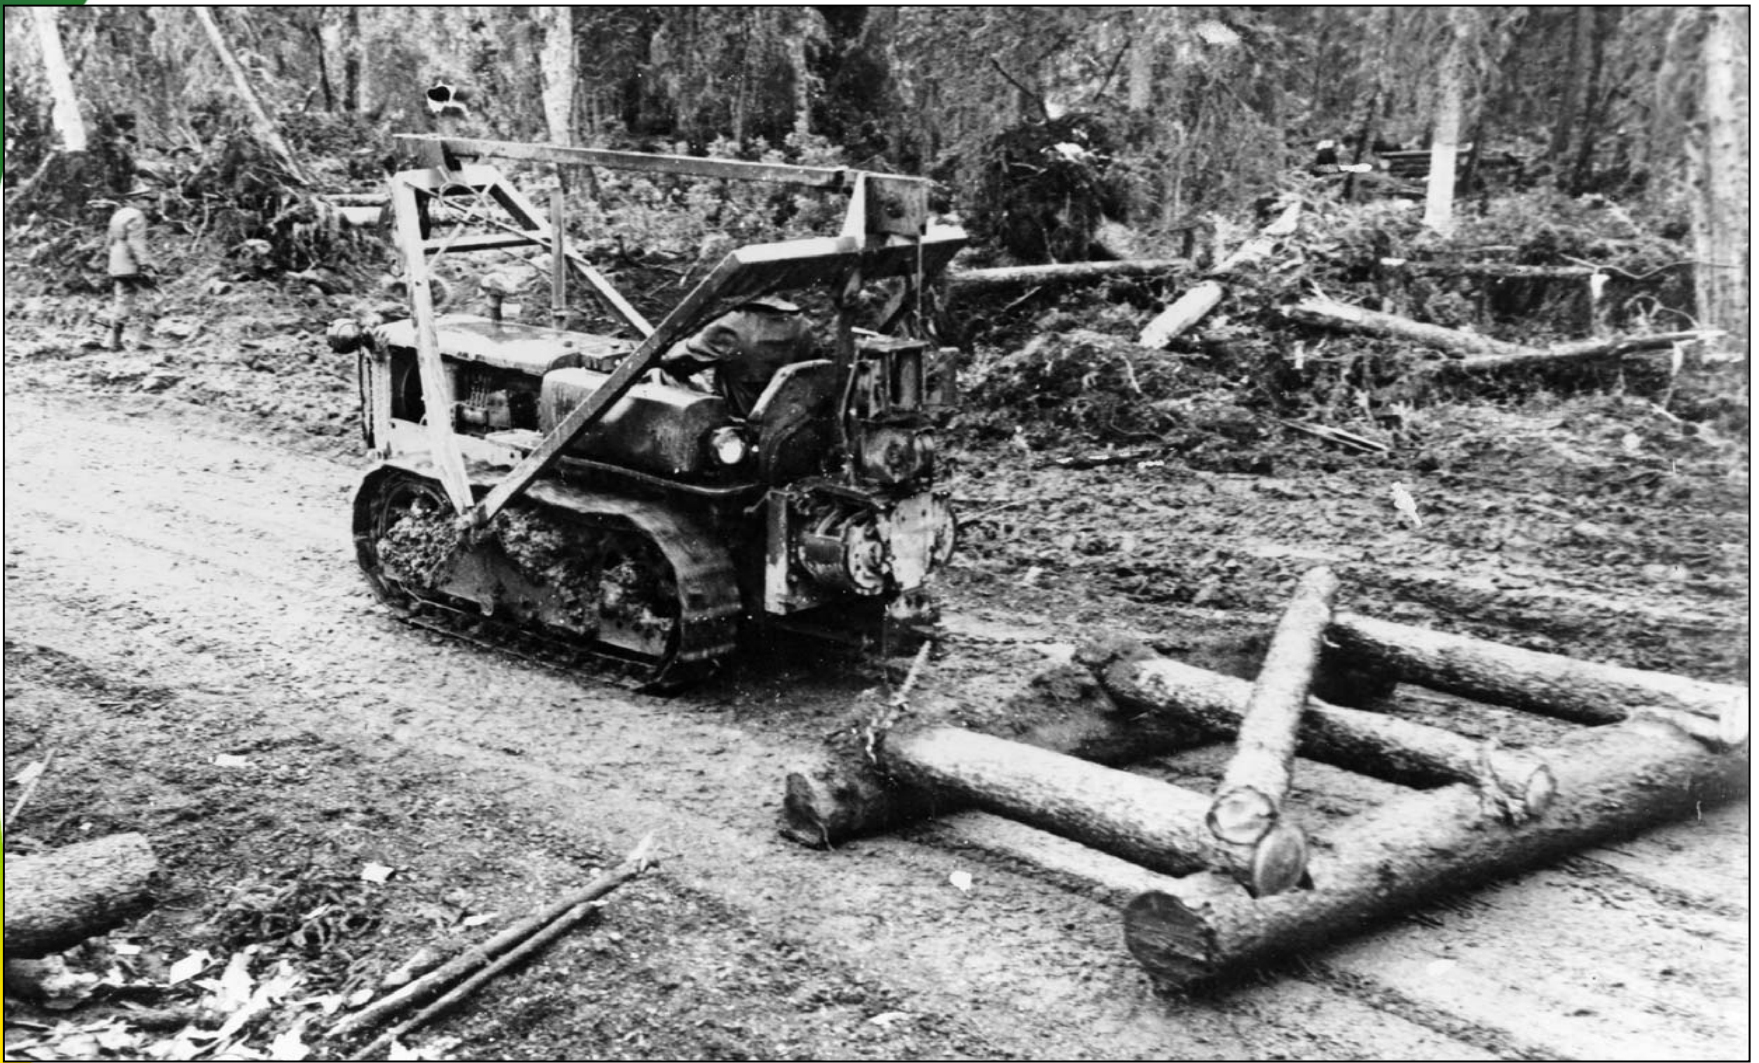
**Until heavier equipment arrived, the Engineers had to be creative, using local supplies to continue construction. Here, a D-4 dozer pulls a makeshift grader made from local timber.**

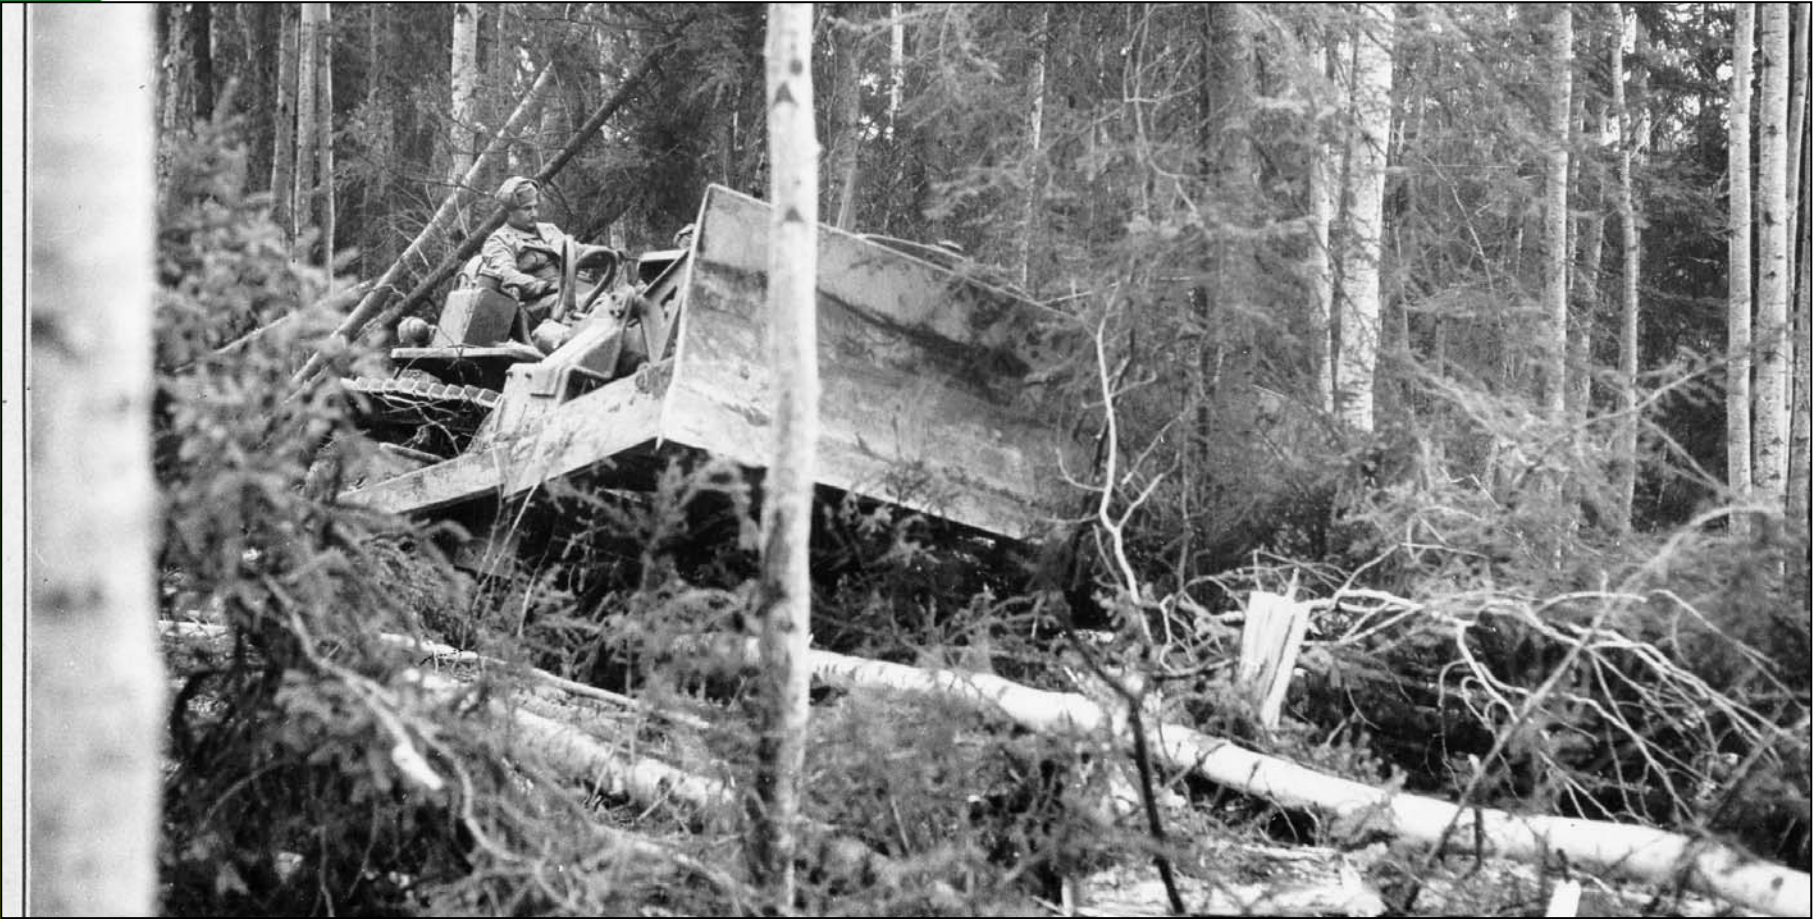
**Once the heavier equipment arrived, clearing a path became easy. Here a D-8 bulldozer clears a path.**

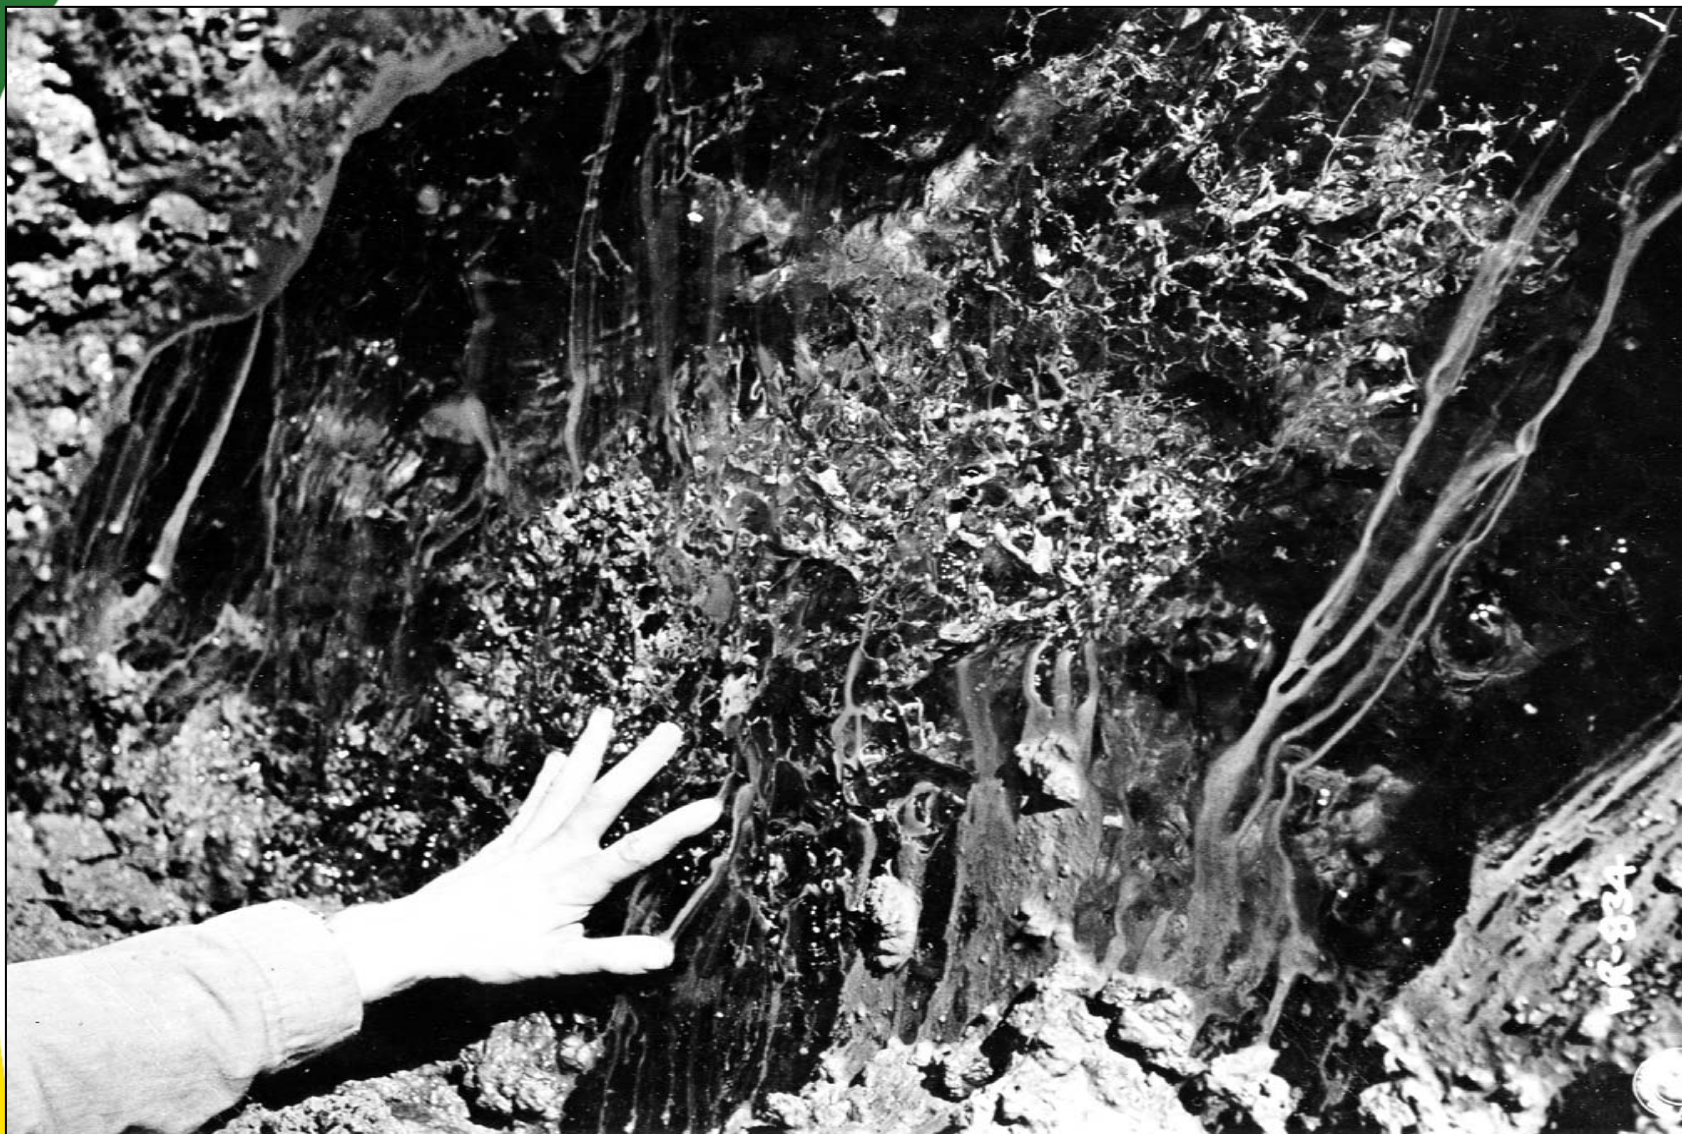
**A typical inclusion of glacial ice found in permafrost. These were impediments to grading, like large boulders.**

- **PERMAFROST** Permafrost is the permanently frozen subsoil beneath cover of vegetation and top soil. The topsoil insulates the frozen subsoil. When constructing a road, it is common procedure to remove the topsoil. But, when the topsoil was excavated, the permafrost began to melt and turn everything into mud.
- Another problem the Engineers faced were with the Muskegs. A muskeg is like a muddy version of quicksand. A vehicle would pass through a muskeg once, but within a short time, the area would turn into complete mud, losing shear strength. Once caught, a vehicle had to be pulled out.
- On top of these foundation problems, everyone had to deal with the cold (frostbite was very common), gnats, and innumerable mosquitoes.

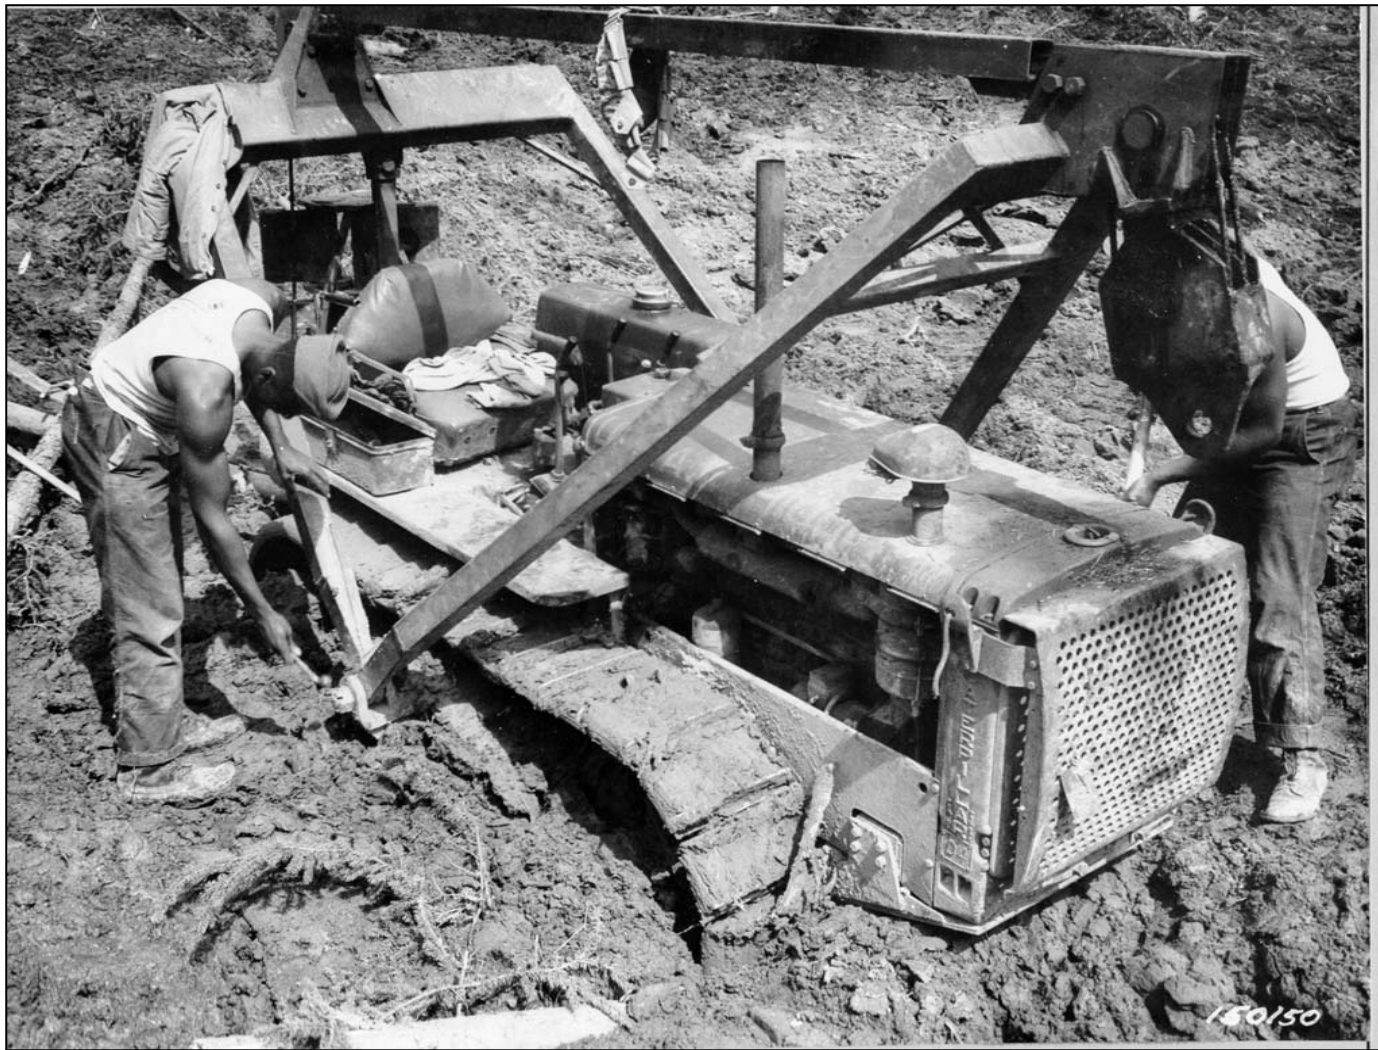
**Stuck in the mud. The Engineers quickly learned about permafrost and the effect it had on equipment when the permafrost cover was removed or disturbed.**

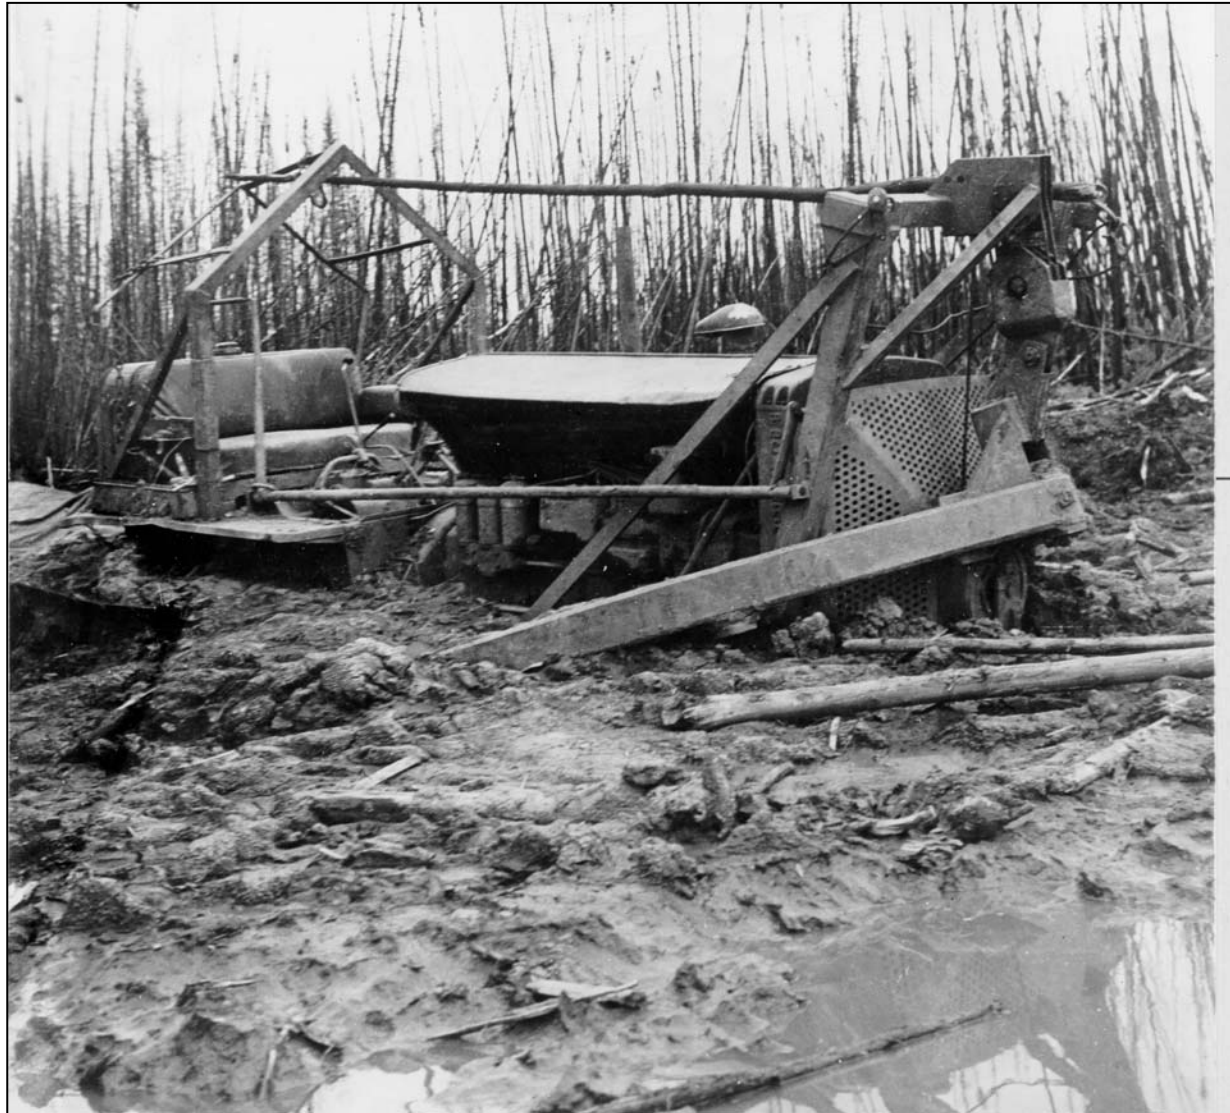
- **Muskegs sometimes appeared to “swallow” the heavier equipment, exhibiting thixotropy .**

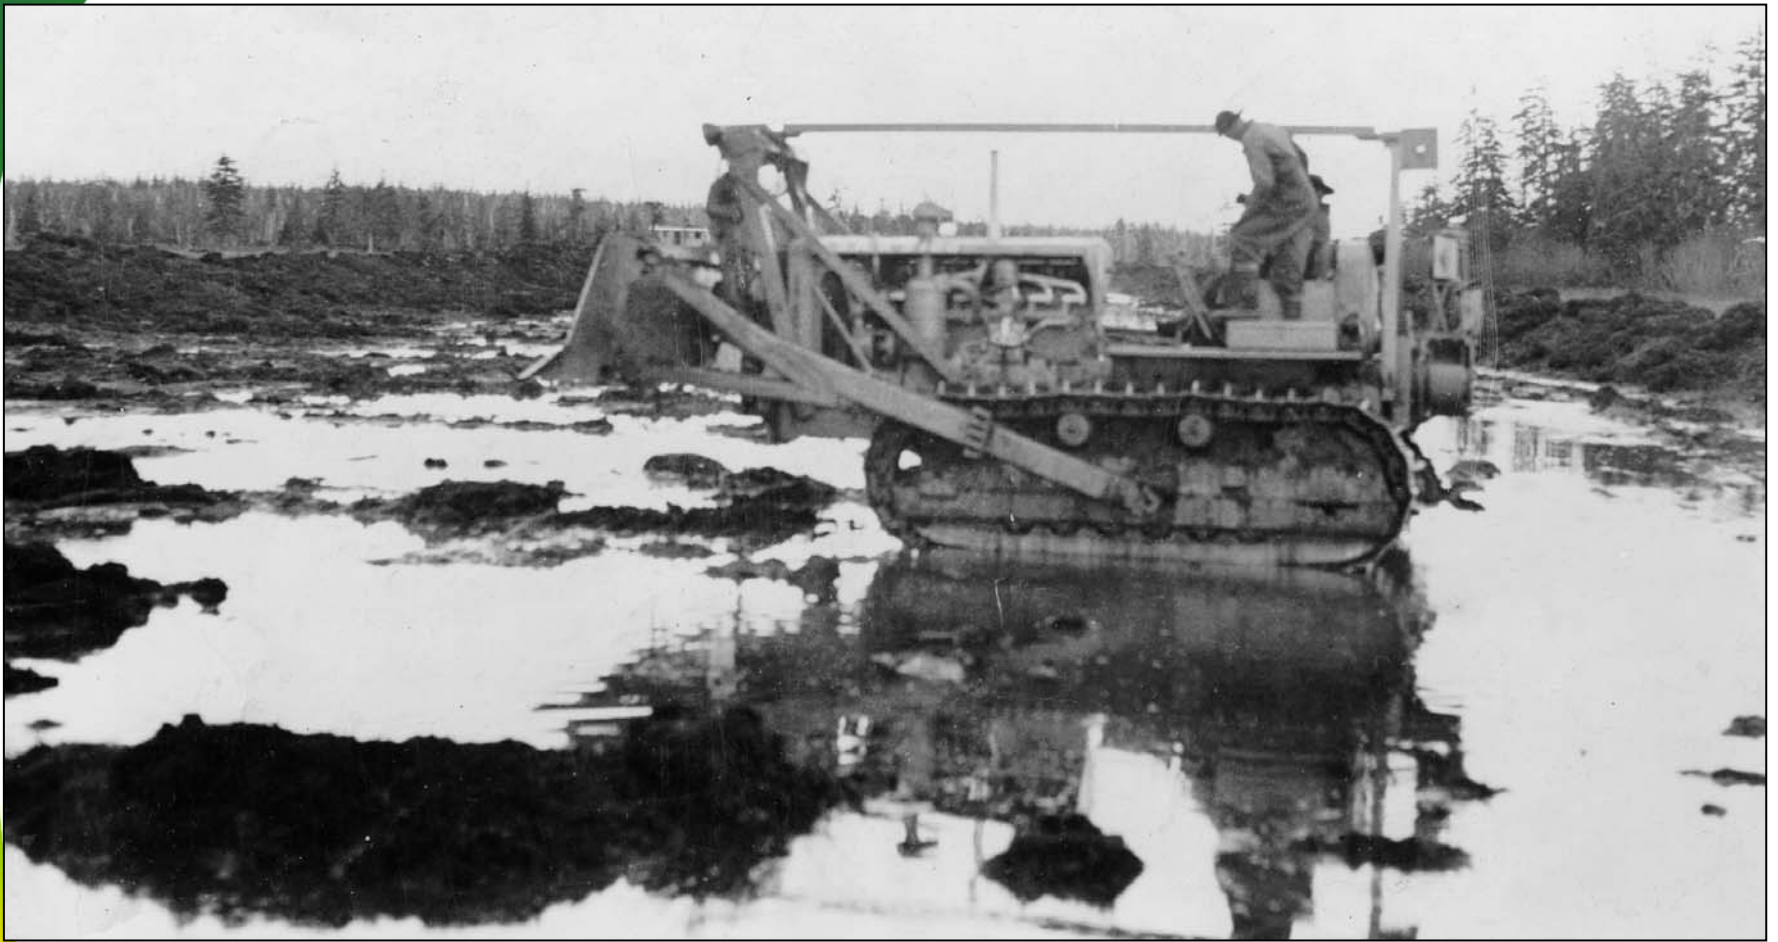
**A road in a muskeg without corduroy.**

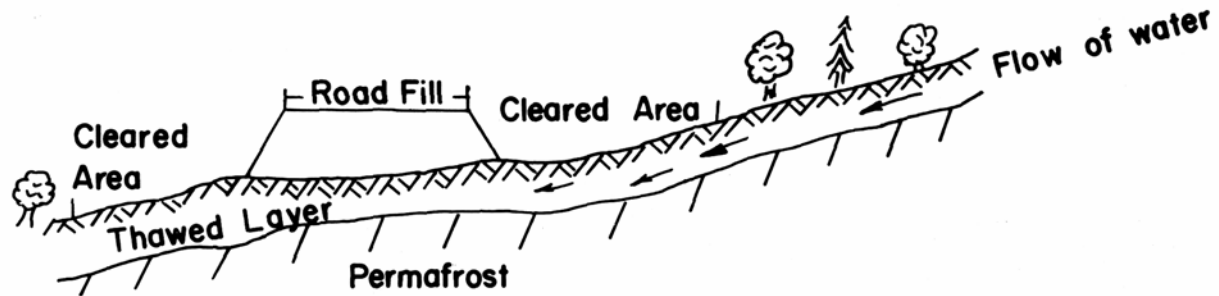
## CONDITION DURING SUMMER

- Seasonal permafrost problems were the largest engineering problem to overcome in maintaining the Alcan Highway

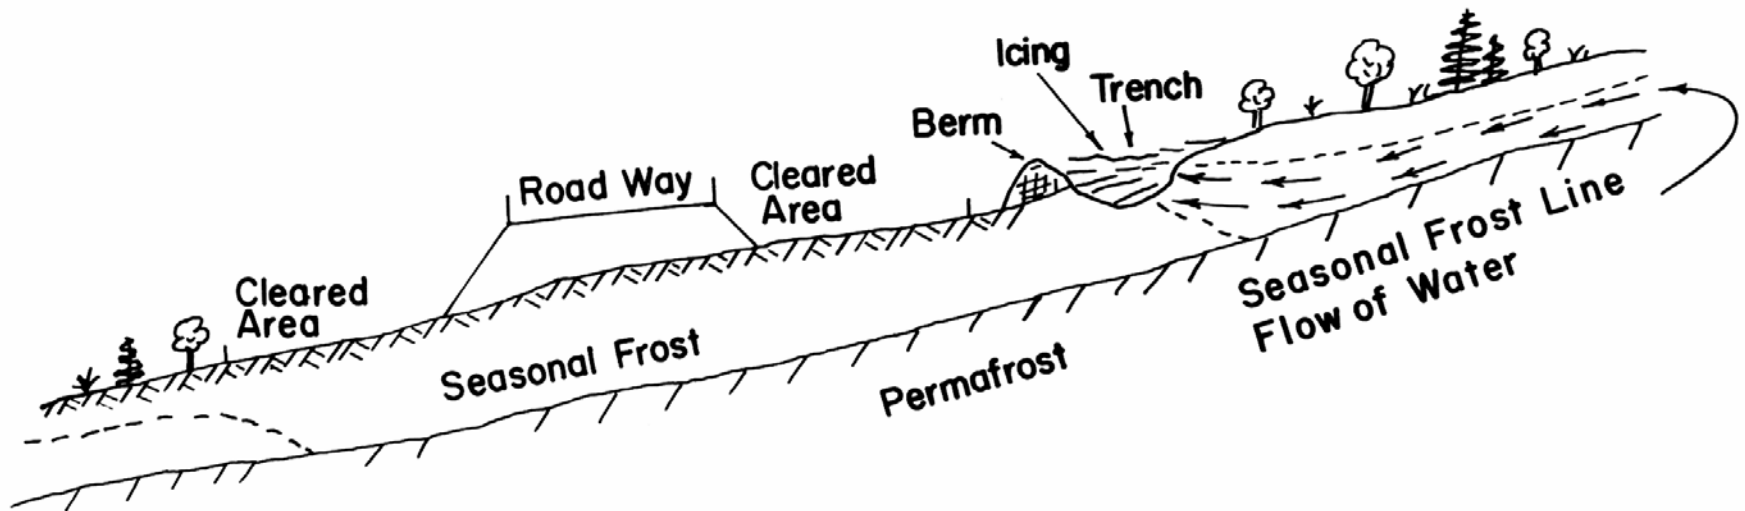
## METHOD OF PREVENTION

- **Drainage trenches and diversion berms had to be constructed upslope of highway embankments to control seepage during seasonal thaw, as sketched above.**

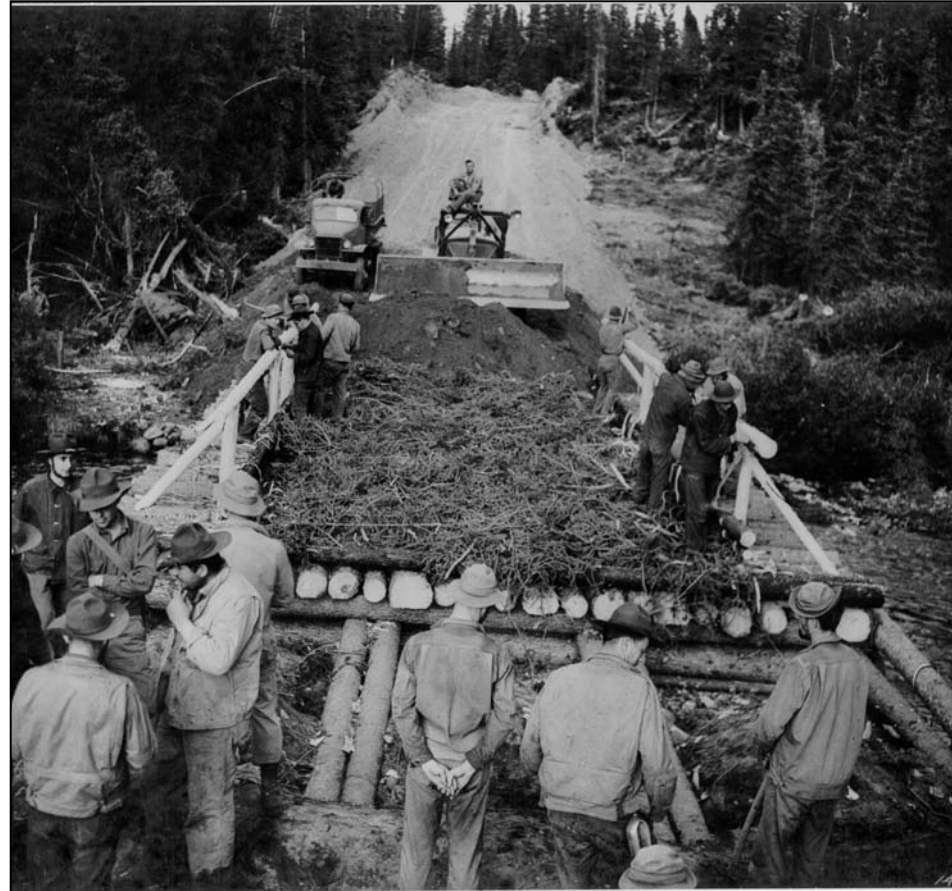
- Culverts were constructed from the surrounding wood. They were intended to be temporary until the contractors came through to improve the road.
- Here you see construction of these temporary culverts. After the wood frame was erected, a bulldozer would fill and level the fill over the top of the culvert.

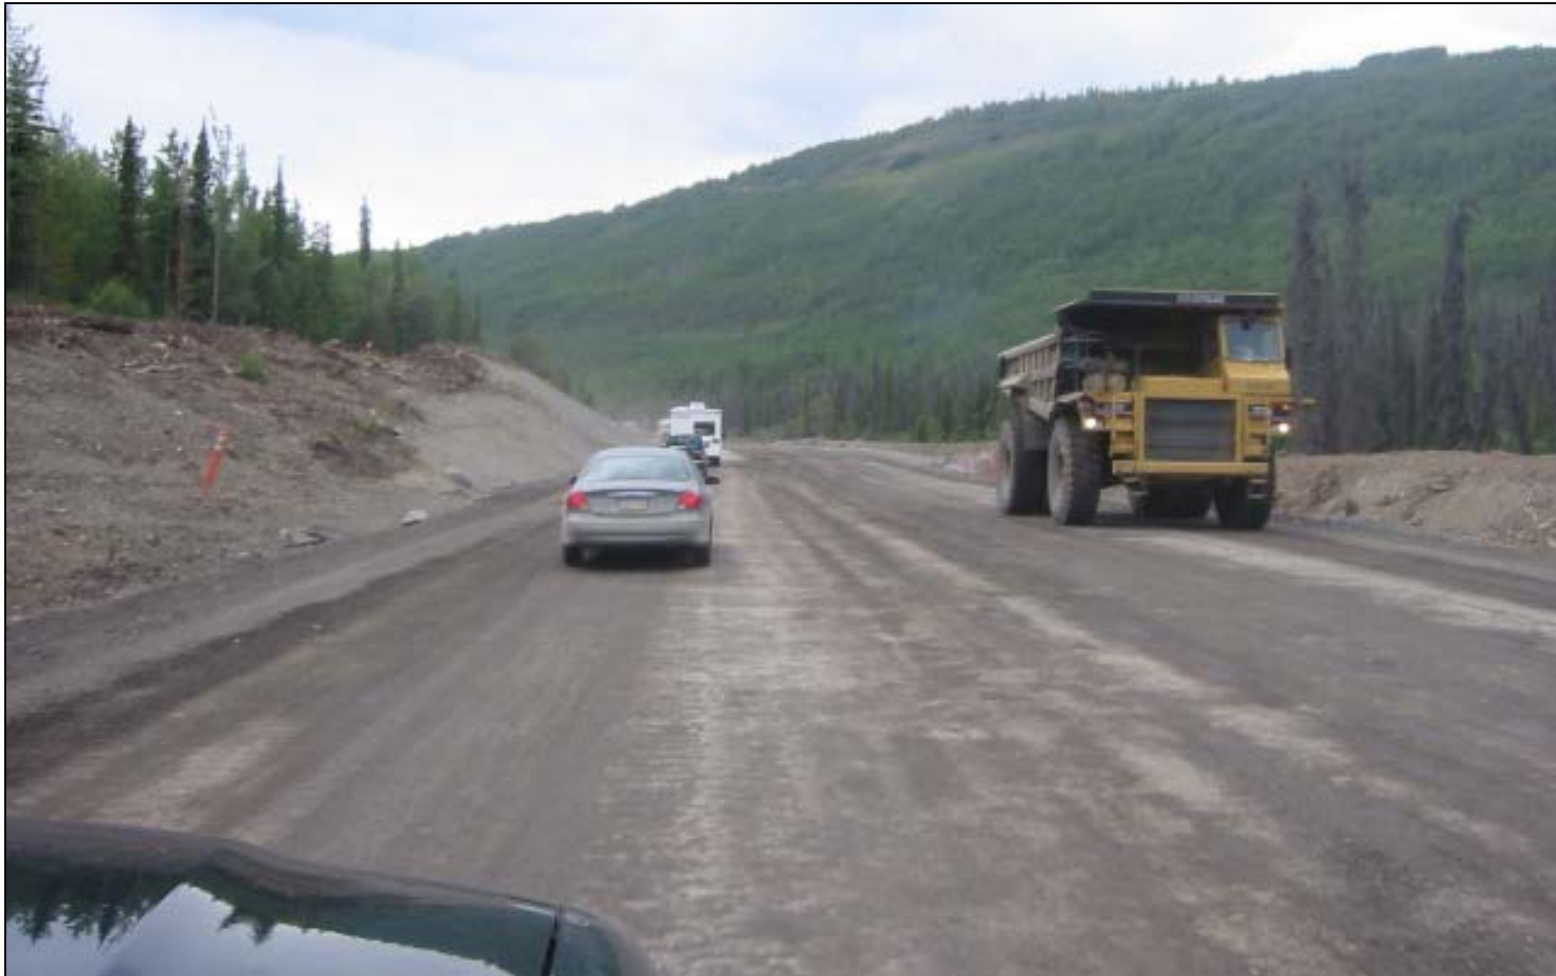
# The Alcan Road Today

- The highway serves as an artery for all manner of traffic, even offroad mining rigs like the one shown here.
