# Construction of the Alcan Highway 1942

**“ One of the Top 10 Construction  
Achievements of the 20th Century”**

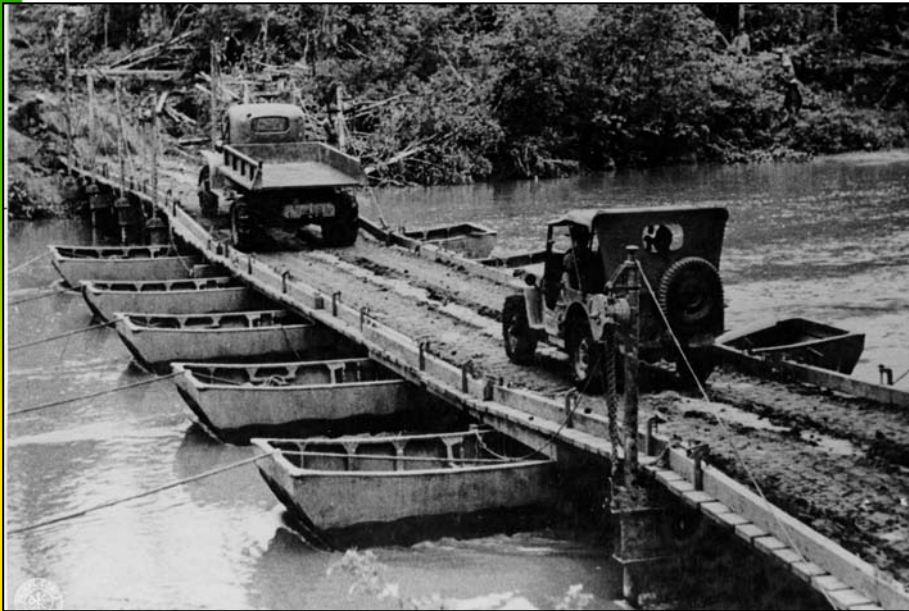
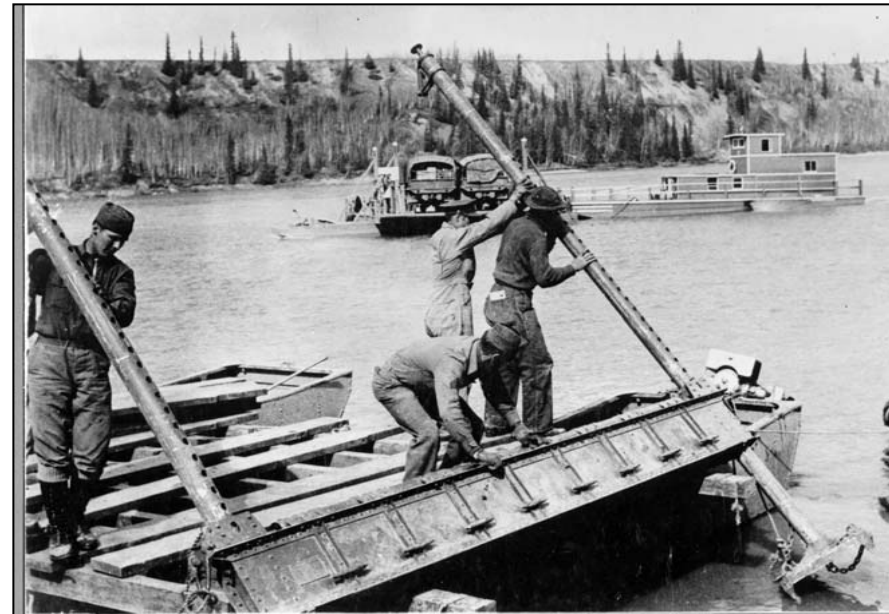
- A temporary pontoon bridge used to expedite construction.
- Pontoons ferrying across equipment

- Throughout the construction of the Alcan Highway, Army Engineers crossed more than 200 rivers. During the colder months, most traffic crossed ice-covered rivers and forded the smaller streams. Once the spring thaw arrived, the 73rd and 74th Engineer Light Pontoon Companies went to work constructing temporary pontoon bridges.
- The first bridges constructed by the Army Engineers were temporary. They failed when the spring thaw increased water levels. Spring freshets also brought flotsam in the form of tree trunks and brush, which slammed into the pilings, damaging them and capturing more and more debris because of the obstructions.
- When the water levels were high during the spring thaw and flood seasons, equipment crossed the swollen rivers by ferry or treadway pontoon bridge.

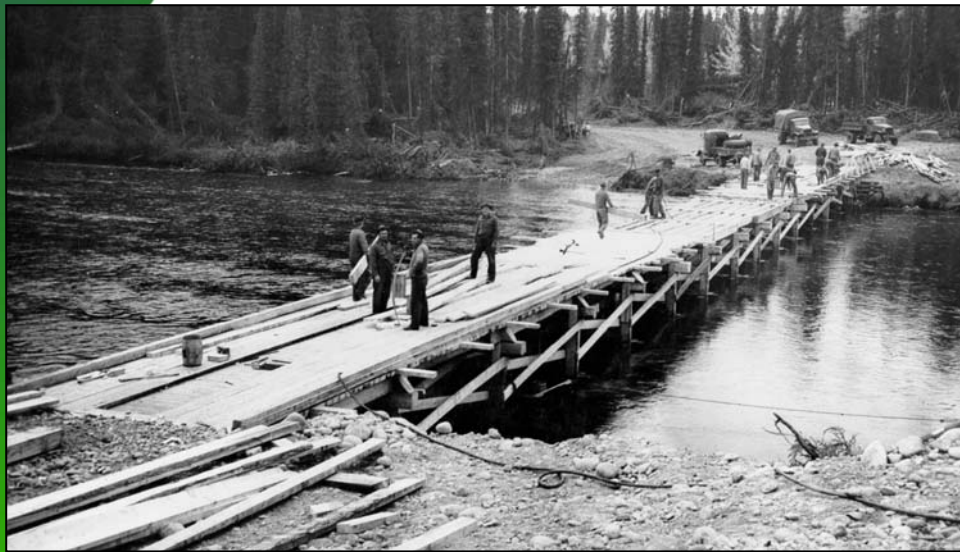
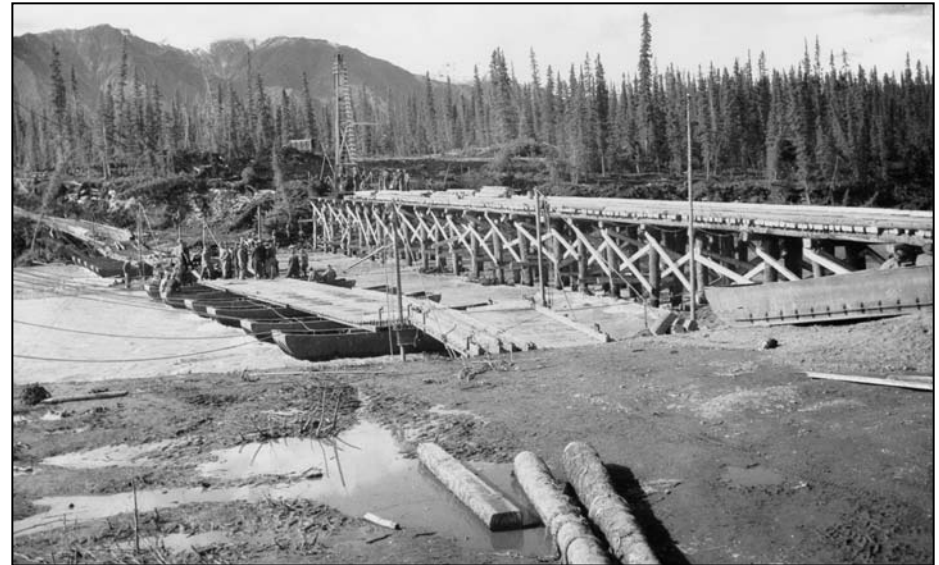
# SEASONAL BRIDGES

The pontoon bridges and ferries were only temporary solutions until permanent bridges could be built. Using 3 sawmills, construction crews and members of the PRA constructed bridges along the entire alignment, even during winter.

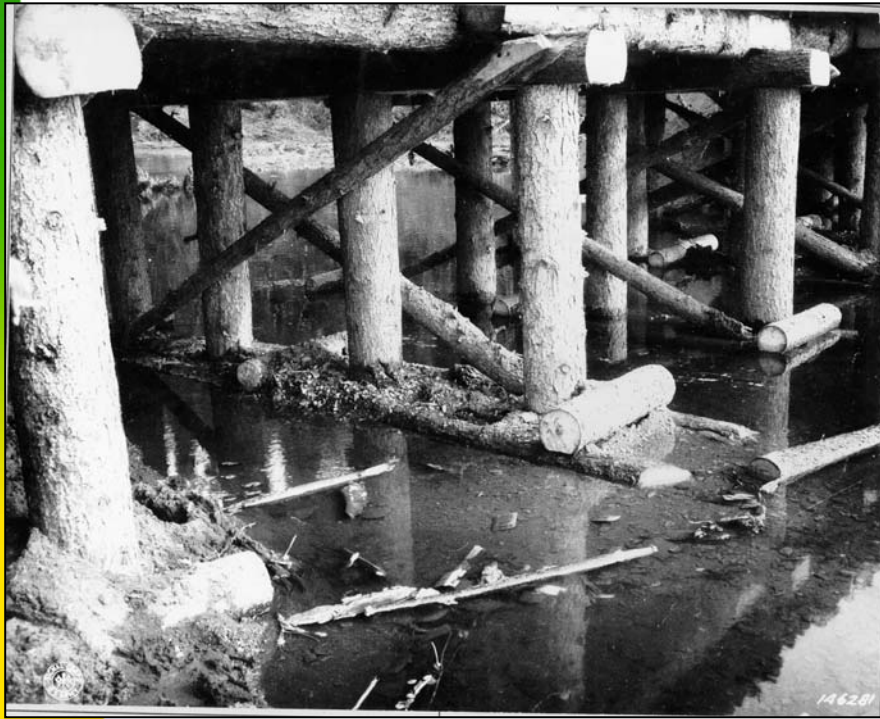
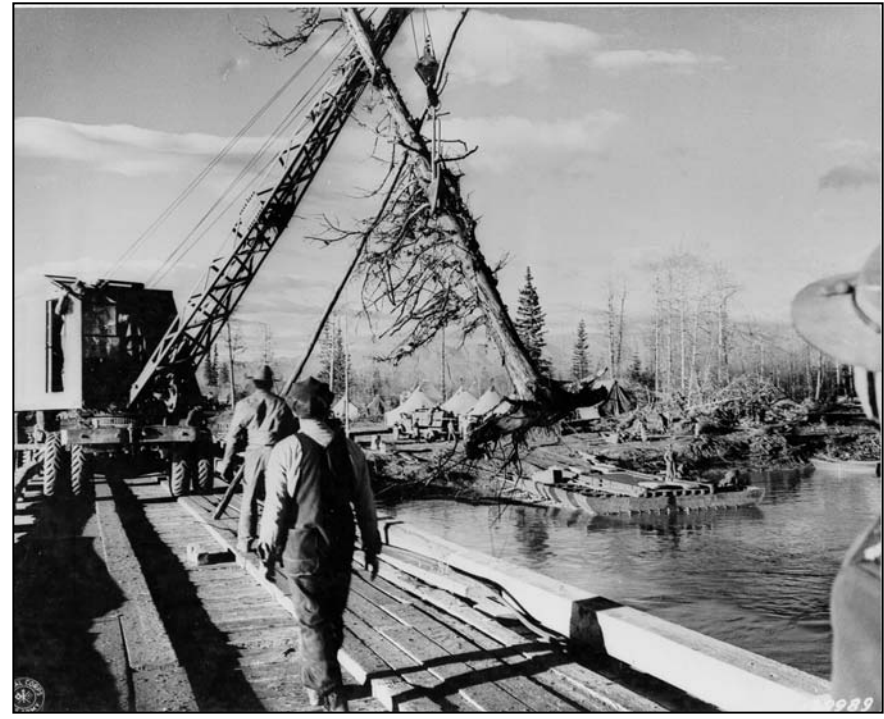
- **Maintaining the bridges posed the biggest problem. During construction, a guard was posted to make sure that large trees brought downstream did not get snagged by the bridge pilings, which could easily damage or destroy the bridge.**
